# Worth Their Salt

# Contractor Cuts on World's Longest Floating Saltwater Bridge

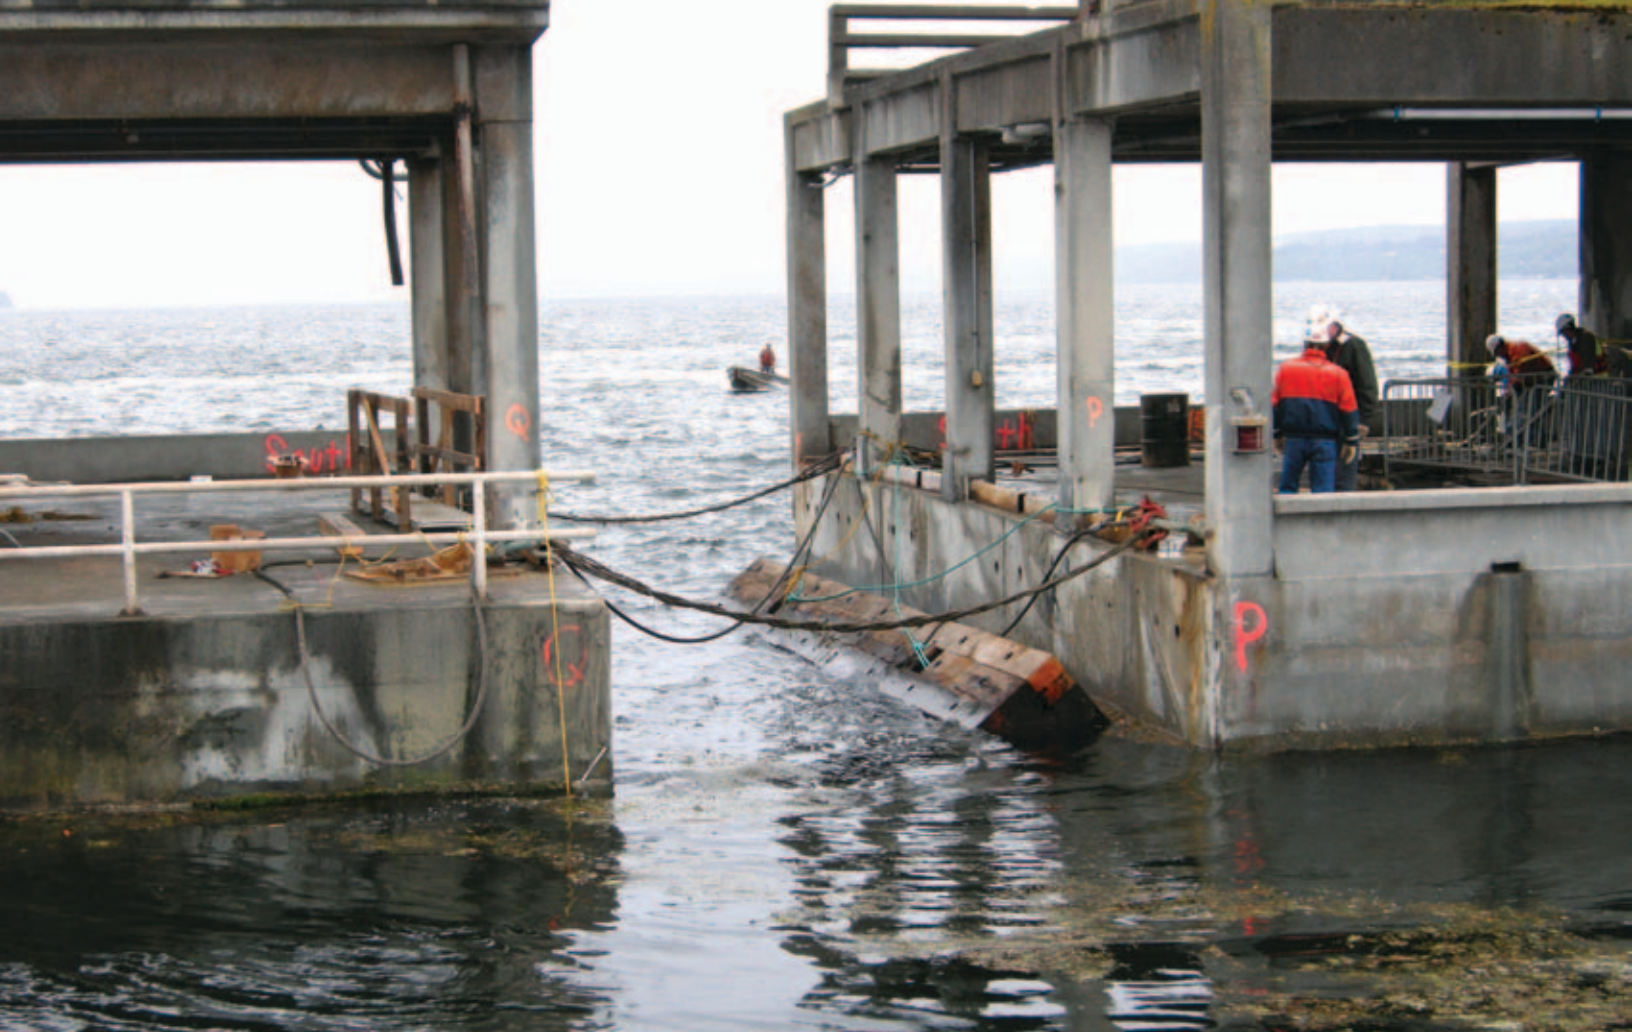
The bridge pontoons were joined by 3.5-inch tendons and 1.5-inch bolts.

The 14-foot-high by 50-foot-wide floating pontoons were joined together by 80 1.5-inch bolts and 24 3.5-inch tendons. The high-tensioned pipe tendons had 12 0.5-inch steel cables grouted inside. The pontoon joints were also pressure grouted within a perimeter of heavy rubber molding. Cutting Edge engineered and fabricated clamps that were remotely operated and bolted onto CC1600 hydraulic wall saws made by Diamond Products. These clamps were the key to the success of the May 2009 shutdown, as all primary tendon cutting had

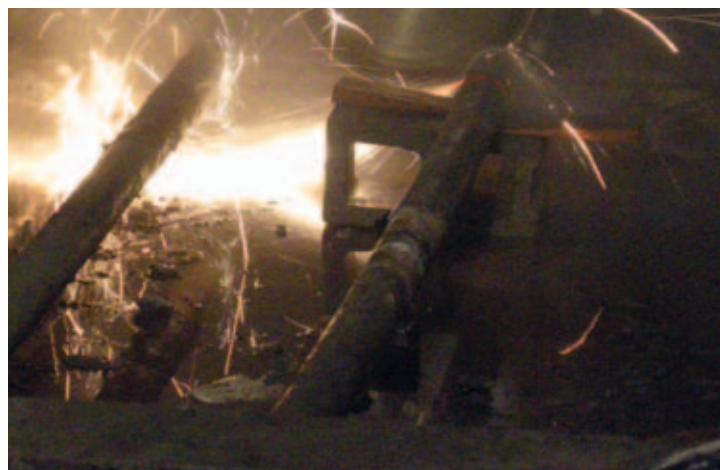
Diamond blades cut through the 1,000-foot, high-tensioned tendons with speed.

to be done or made remotely, with no personnel allowed below deck. Following the completion of the tendon cuts with the wall saws, four wire saws were used to separate the pontoons.

Several months of design and trial cutting were done on sections of tendons, including test cuts on location prior to the outage. Angular core holes were then drilled into the upper corners of each planned separation, to allow for initial wire cuts and re-tensioning prior to commencing the primary wire cuts on May 1. Once the clamped wall saws were in place, actual cutting time was less than three minutes per tendon. Due to the pre-stressing of the tendons, the initial cut on the 1,000-foot tendons caused a separation of more than 15 feet.

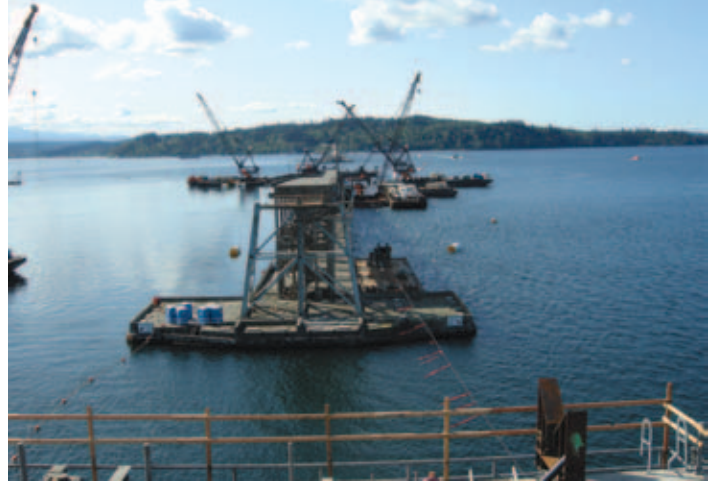
Some of the pontoon sections were as long as three football fields.

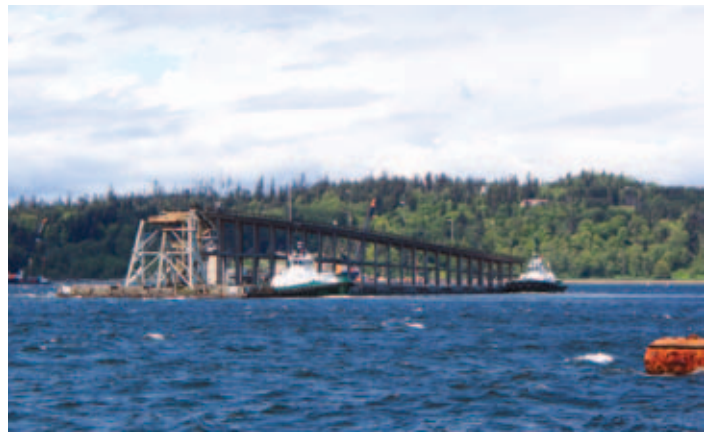
The cut pontoons were towed north to be reemployed as floating piers.

As for the disposition of the existing pontoons—they were taken to Vancouver, British Columbia, where they were sold to a company that will convert them into floating piers.

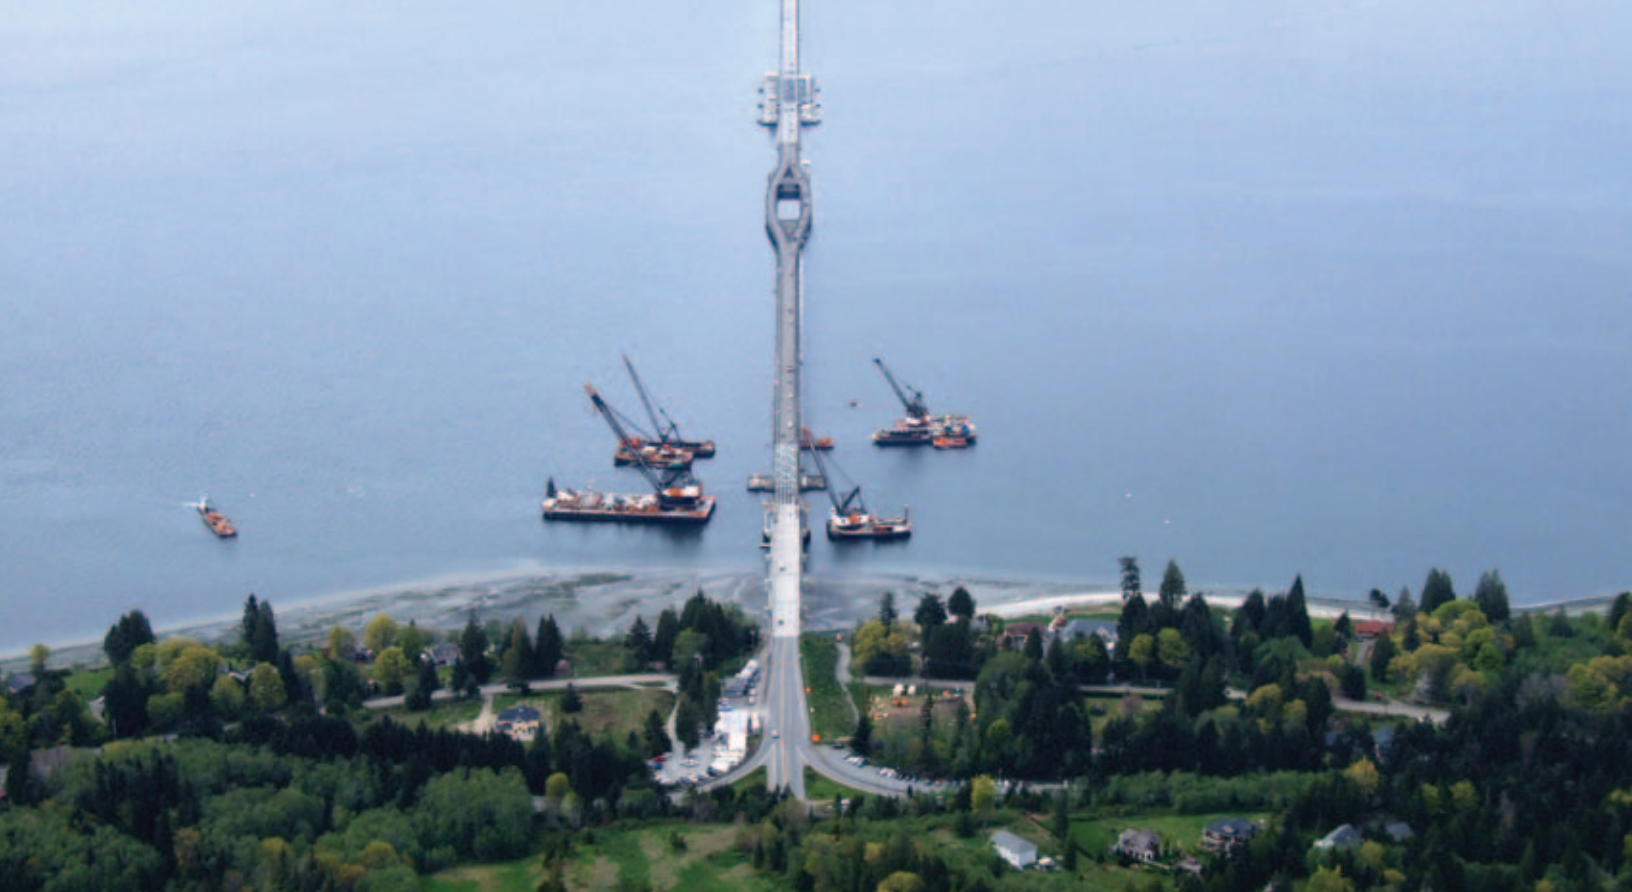
Aerial view of the Hood Canal Bridge during the course of the work.
