Break in the Bahamas

Cutters Head to the Caribbean to Wire Saw Sunken Pier

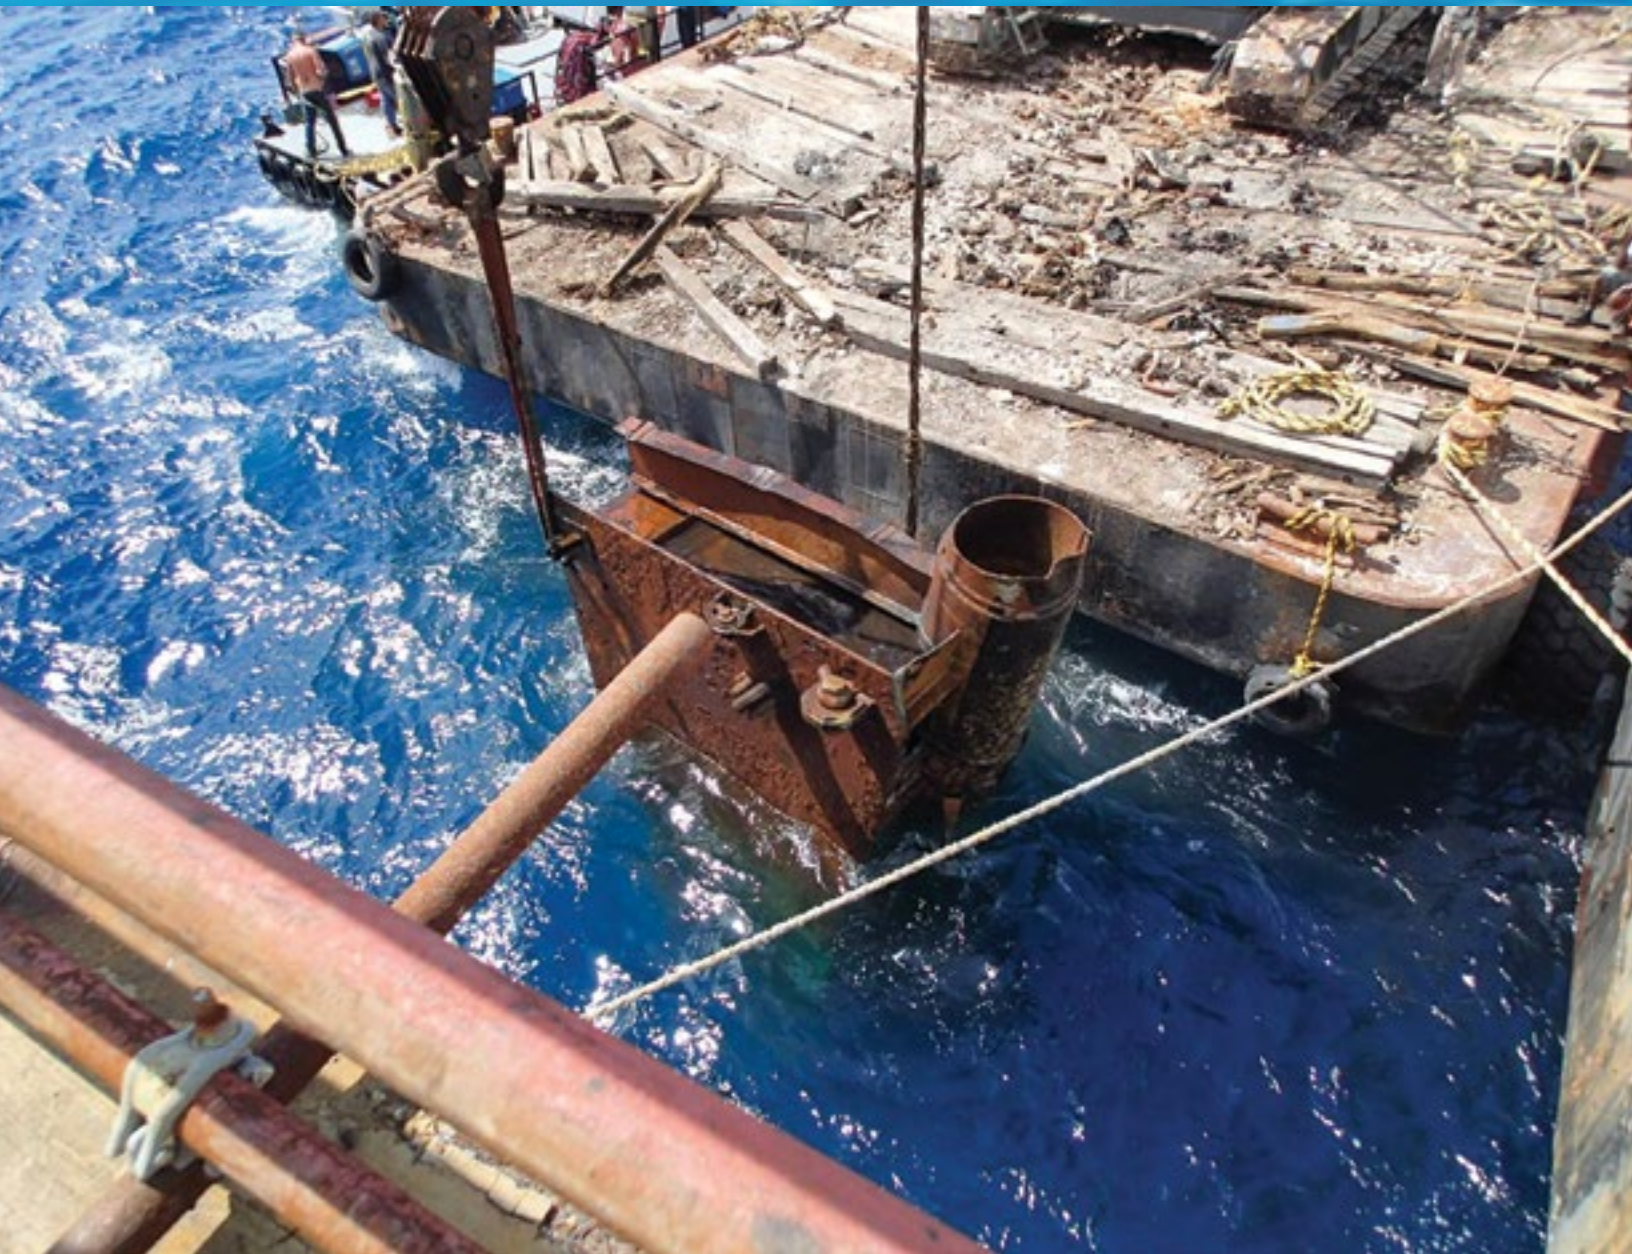
A 25-foot by 25-foot steel pier section had sunk into the water.

The submerged pier was unstable and the bottom sat approximately 30 feet below the surface of the water. The top of the section would break the surface during low tide and be around 6 feet below surface at high tide. The damaged section consisted of a 1.5-inch-thick steel plate measuring 25 feet by 25 feet. The plate needed to be cut into three sections for a barge-mounted crane to lift it from the water and place on a work platform for disposal. The plate was connected to six 3-foot-high I beams, so cuts had to be made through each one to free the sections.

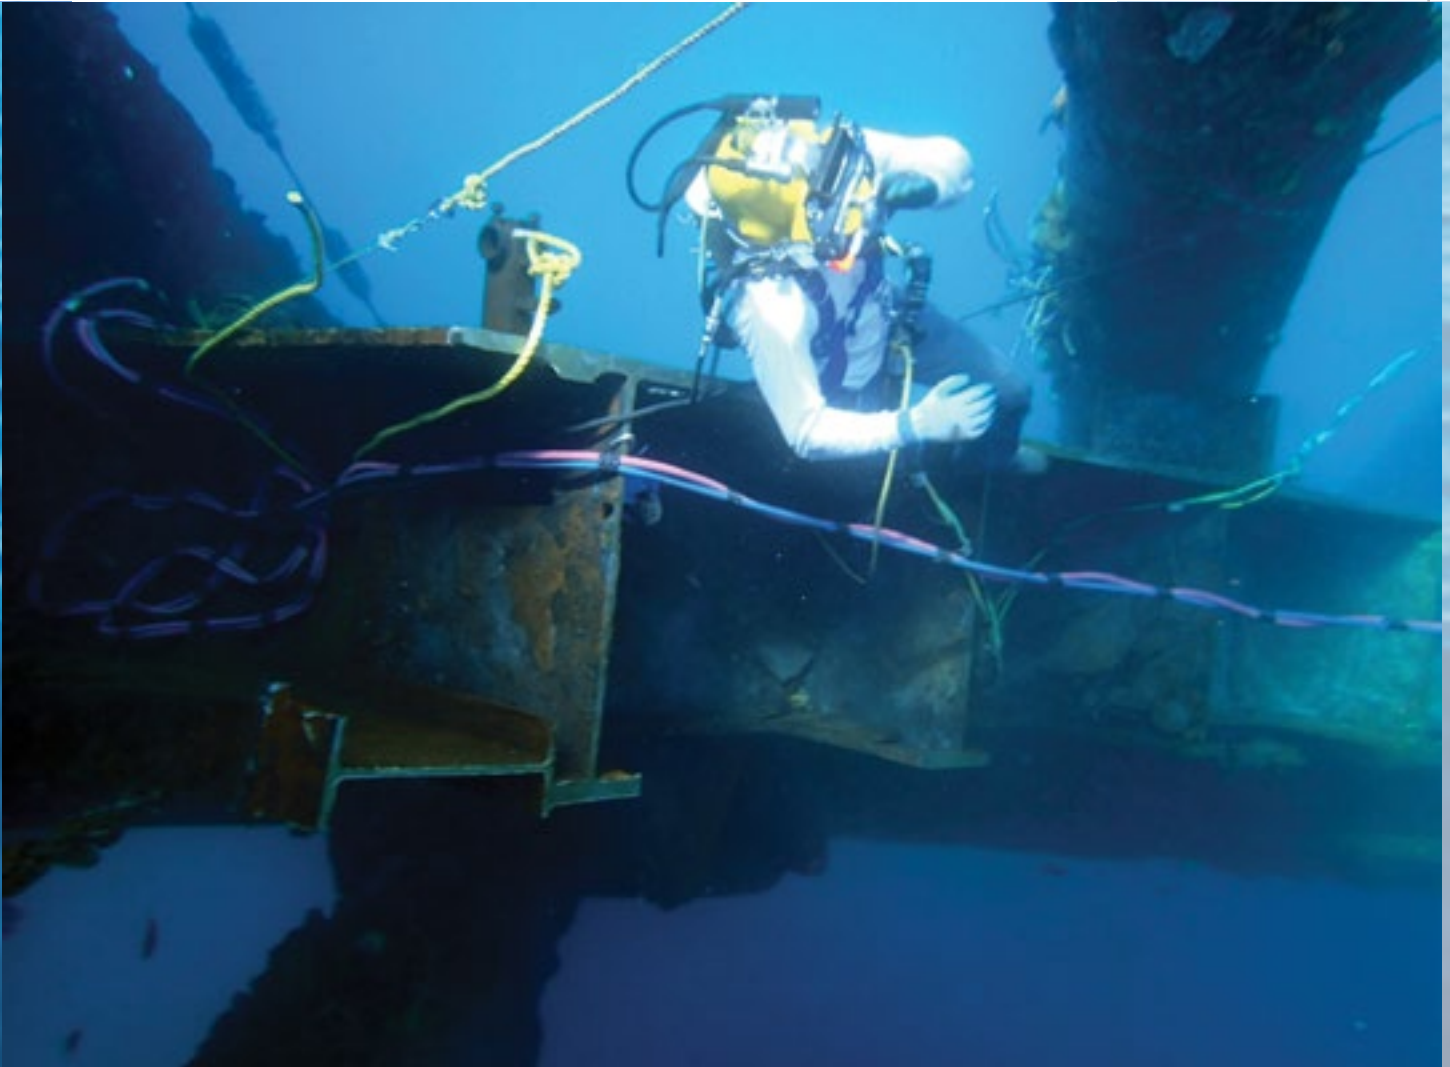
Divers were used to inspect the damaged structure and set up the cuts.

Diamond Products was positioned on the work platform, standing 25 feet above the water. Divers entered the water and captured video to allow ABC/Cutting Edge to assess the situation and create a game plan for the cutting work. Instructions were then given to the divers for the installation of the underwater pulleys, while the cutting team set up pulley stands on the work platform. Custom-fitted fenders were attached to some pulleys to prevent the wire from 'jumping' off while cutting underwater.

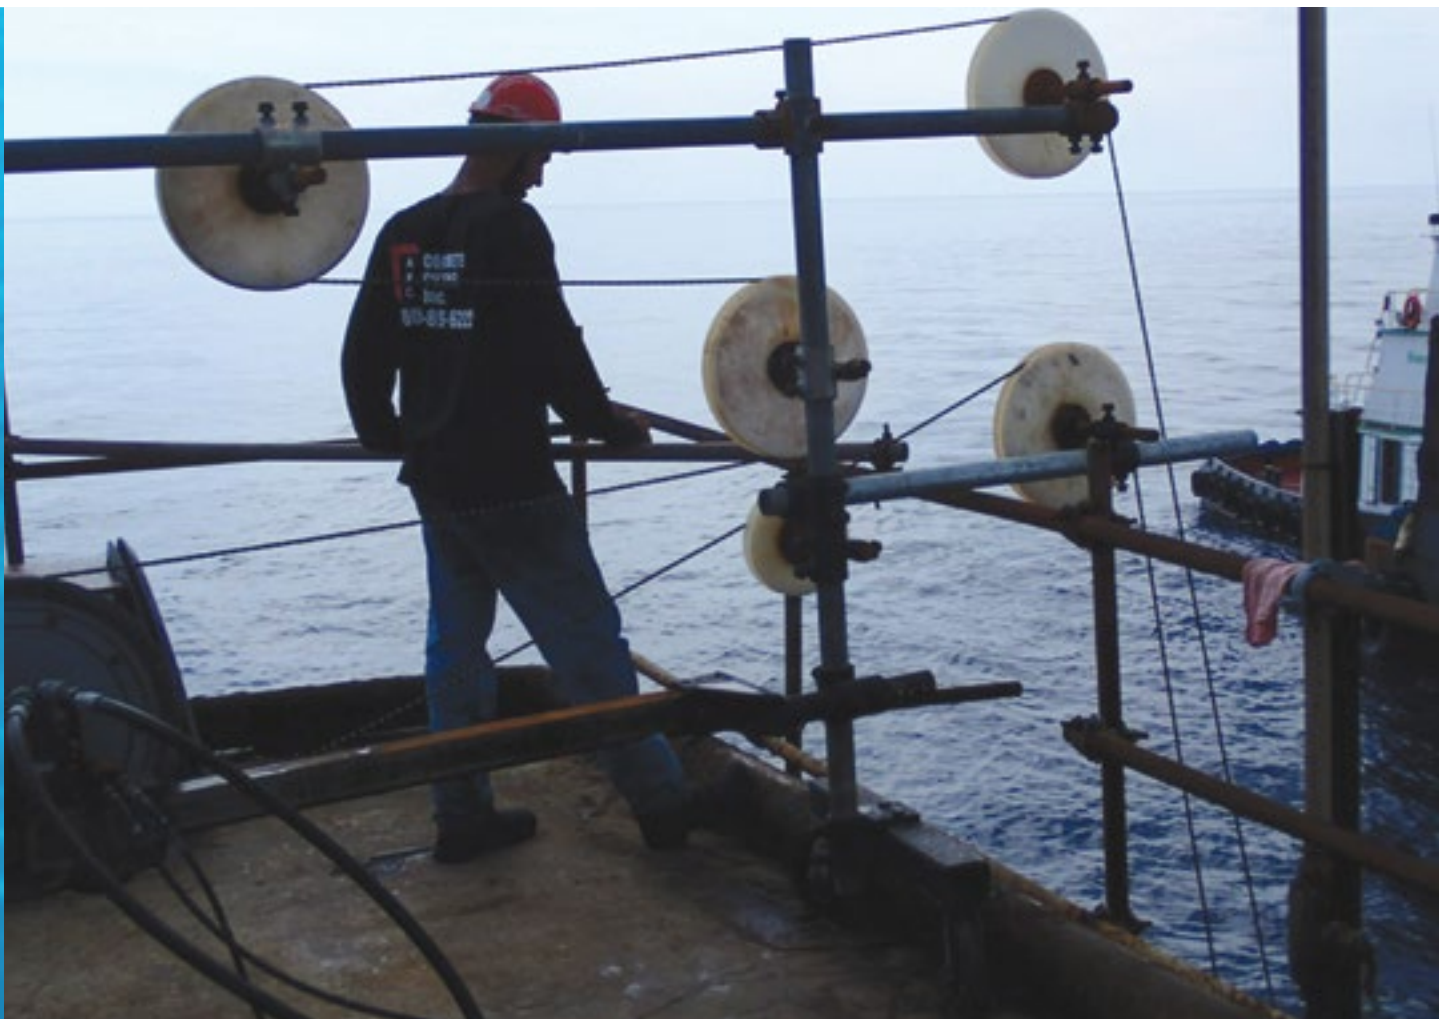
A wire saw was positioned on a work platform 25 feet above the water.

A diving vessel with six divers and two crew members from Orion Marine was employed to support the work of the joint venture. Each day consisted of a 20-minute boat ride to the pier, where a work platform and crane barge were anchored in place. A modified WS25 wire saw from

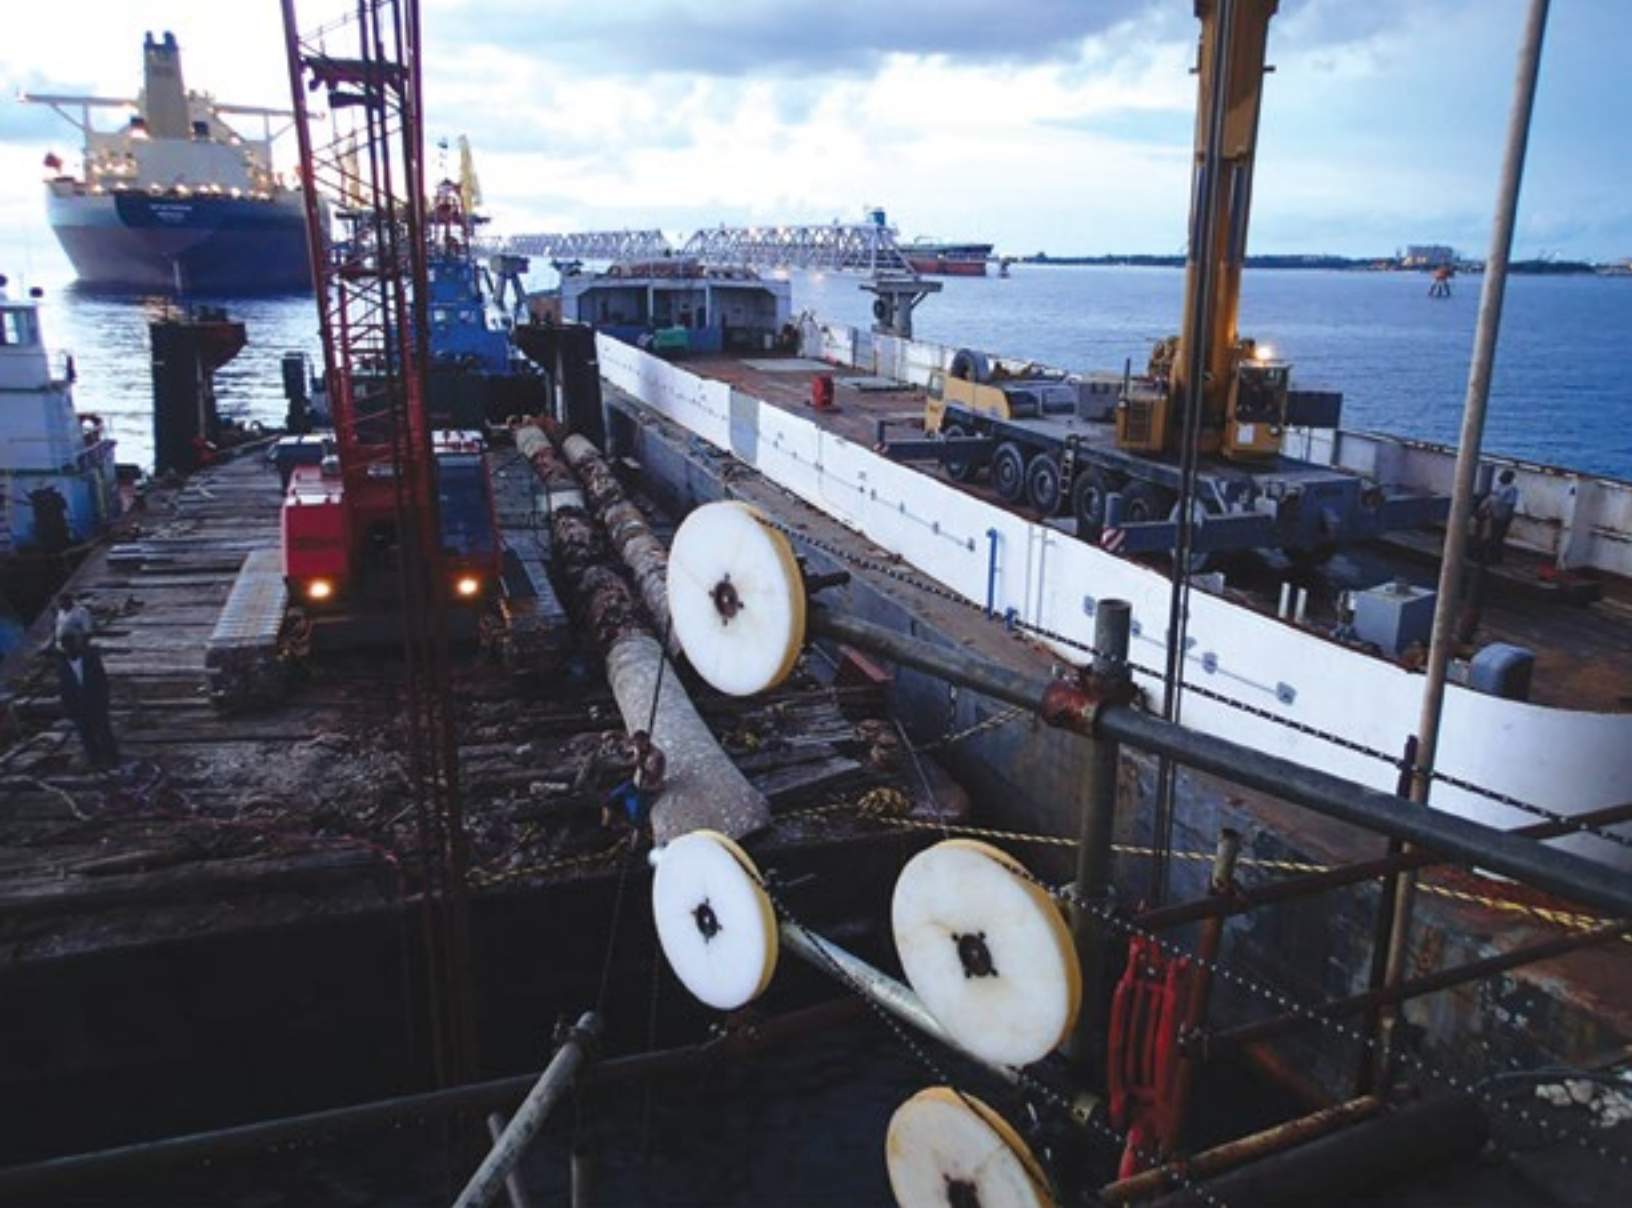
Each wire saw pull cut took around six hours to complete.

With the saw and pulley runs in place, divers began creating starting notches for the pulls using pneumatic power grinders. These notches were necessary, as the sunken plate was at a skewed angle underwater, making it difficult for the wire to get a "bite" on the steel. Diamond wire was run around the system, positioned in the notch and tensioned for the commencement of cutting. Crane rigging was also attached to the cut sections so that they could be lifted from the water once cut free. ABC/Cutting Edge used 140 feet of 10.3-millimeter-diameter (0.4 inches) wire from Tyrolit and ran the saw with 2,800 psi of pressure. Once the equipment and wire run was set up, each pull cut took approximately six hours to complete. Work commenced on September 10 and finished on October 1.

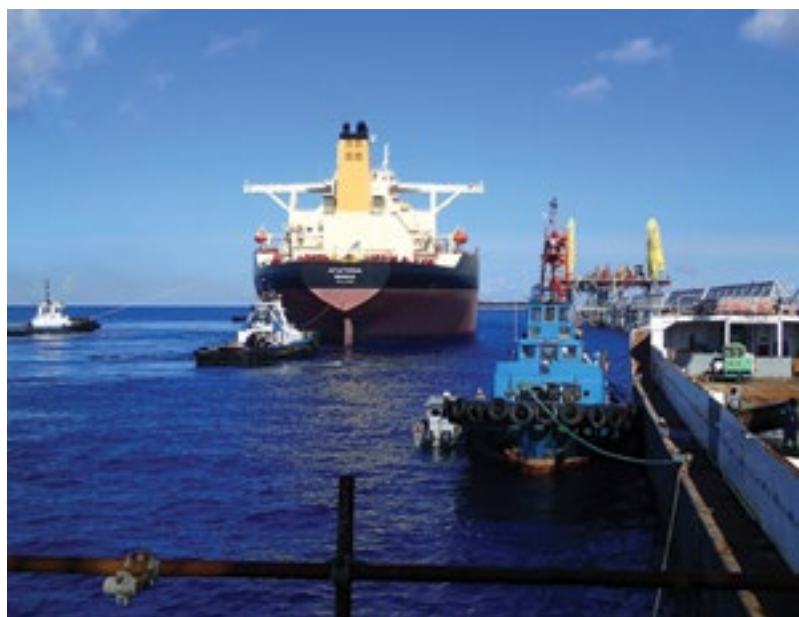
Ships continued to dock at nearby piers while cutting was performed.

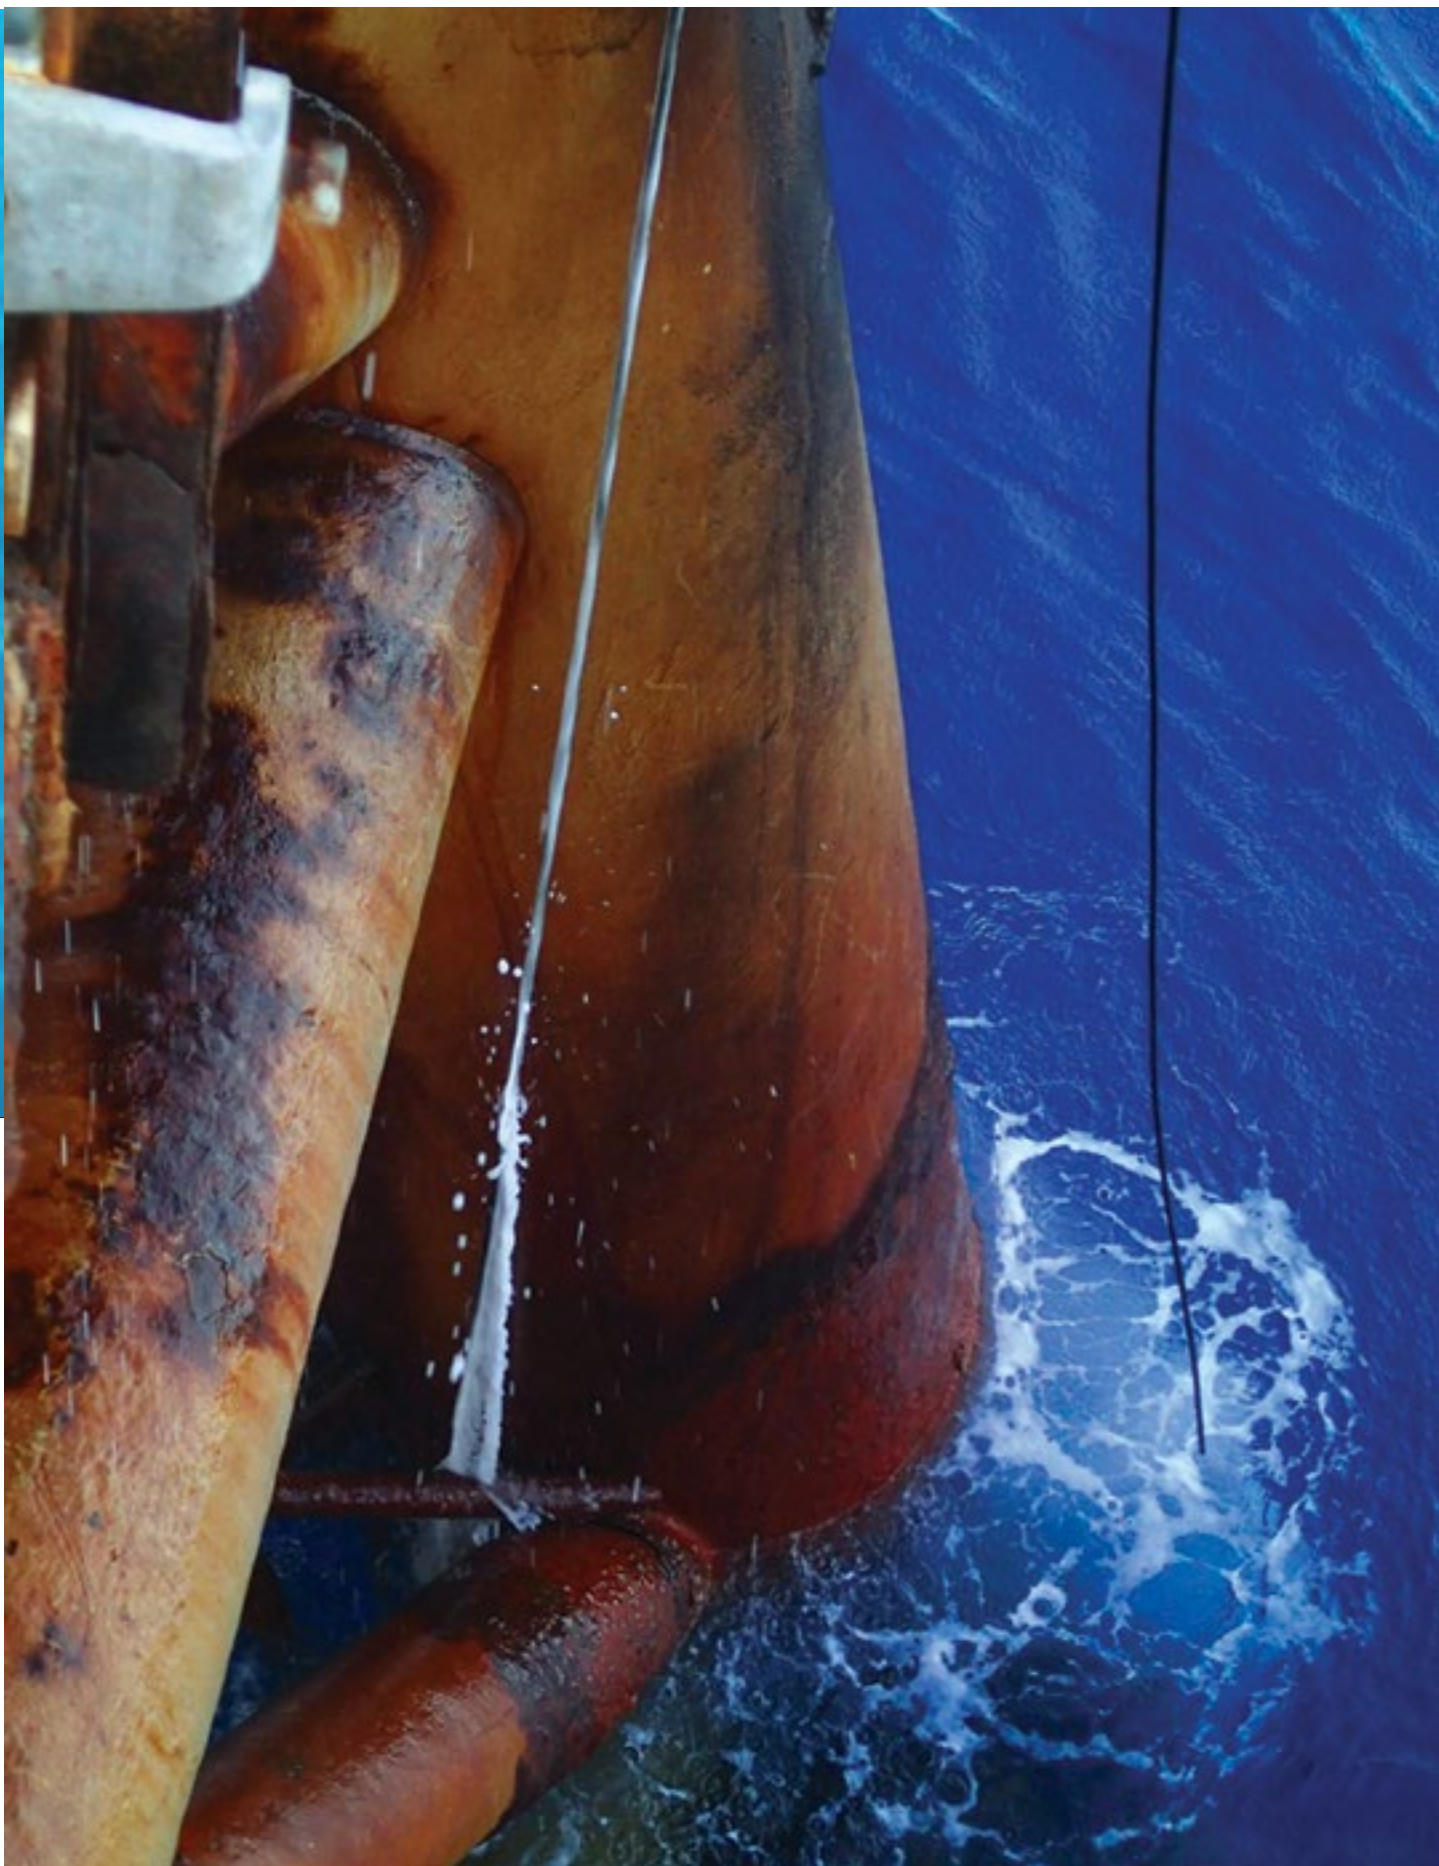
Notches were made in the steel to help the diamond wire get a “bite” on the structure.

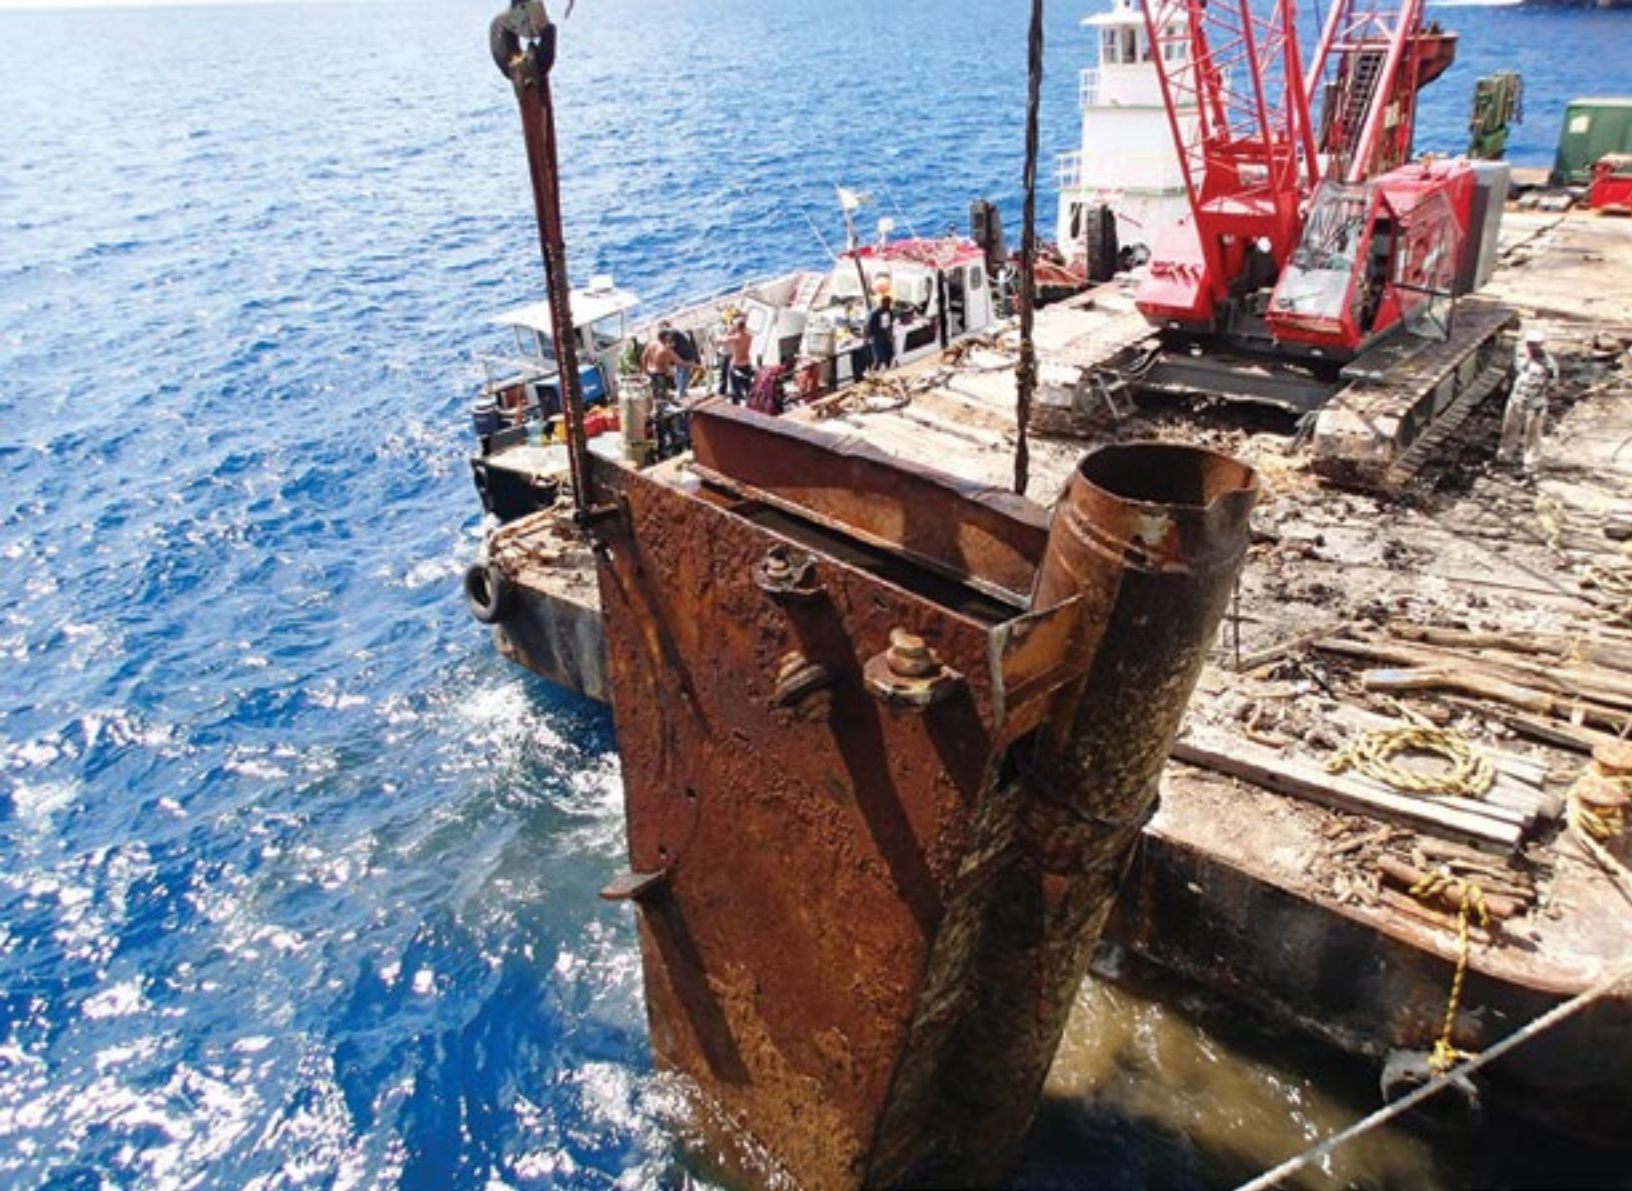
Cut sections were loaded on to work barges by crane for disposal.

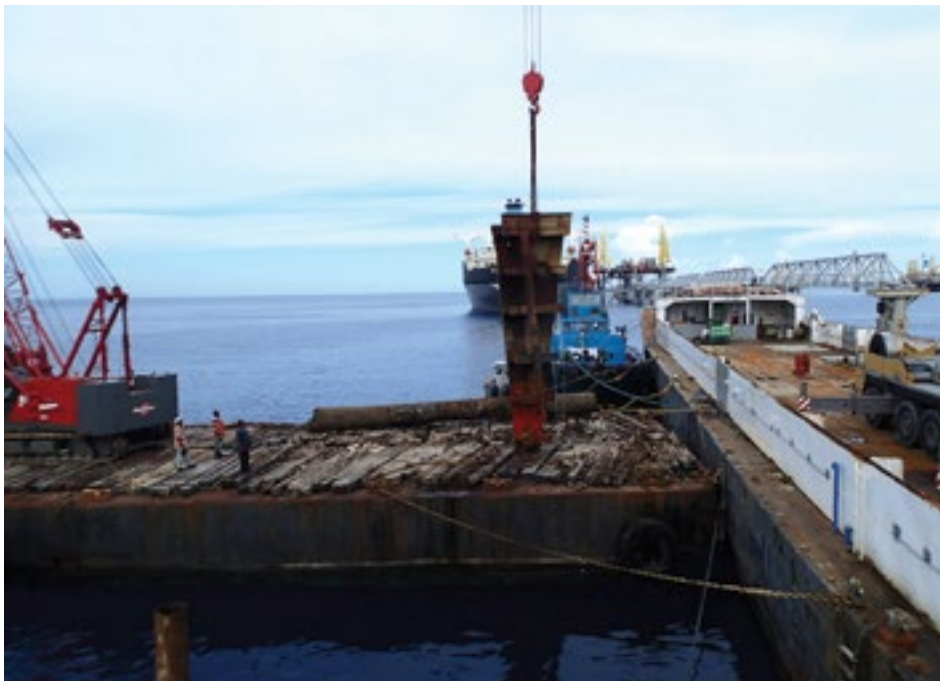
The cut sections had spent months underwater in a damaged state.

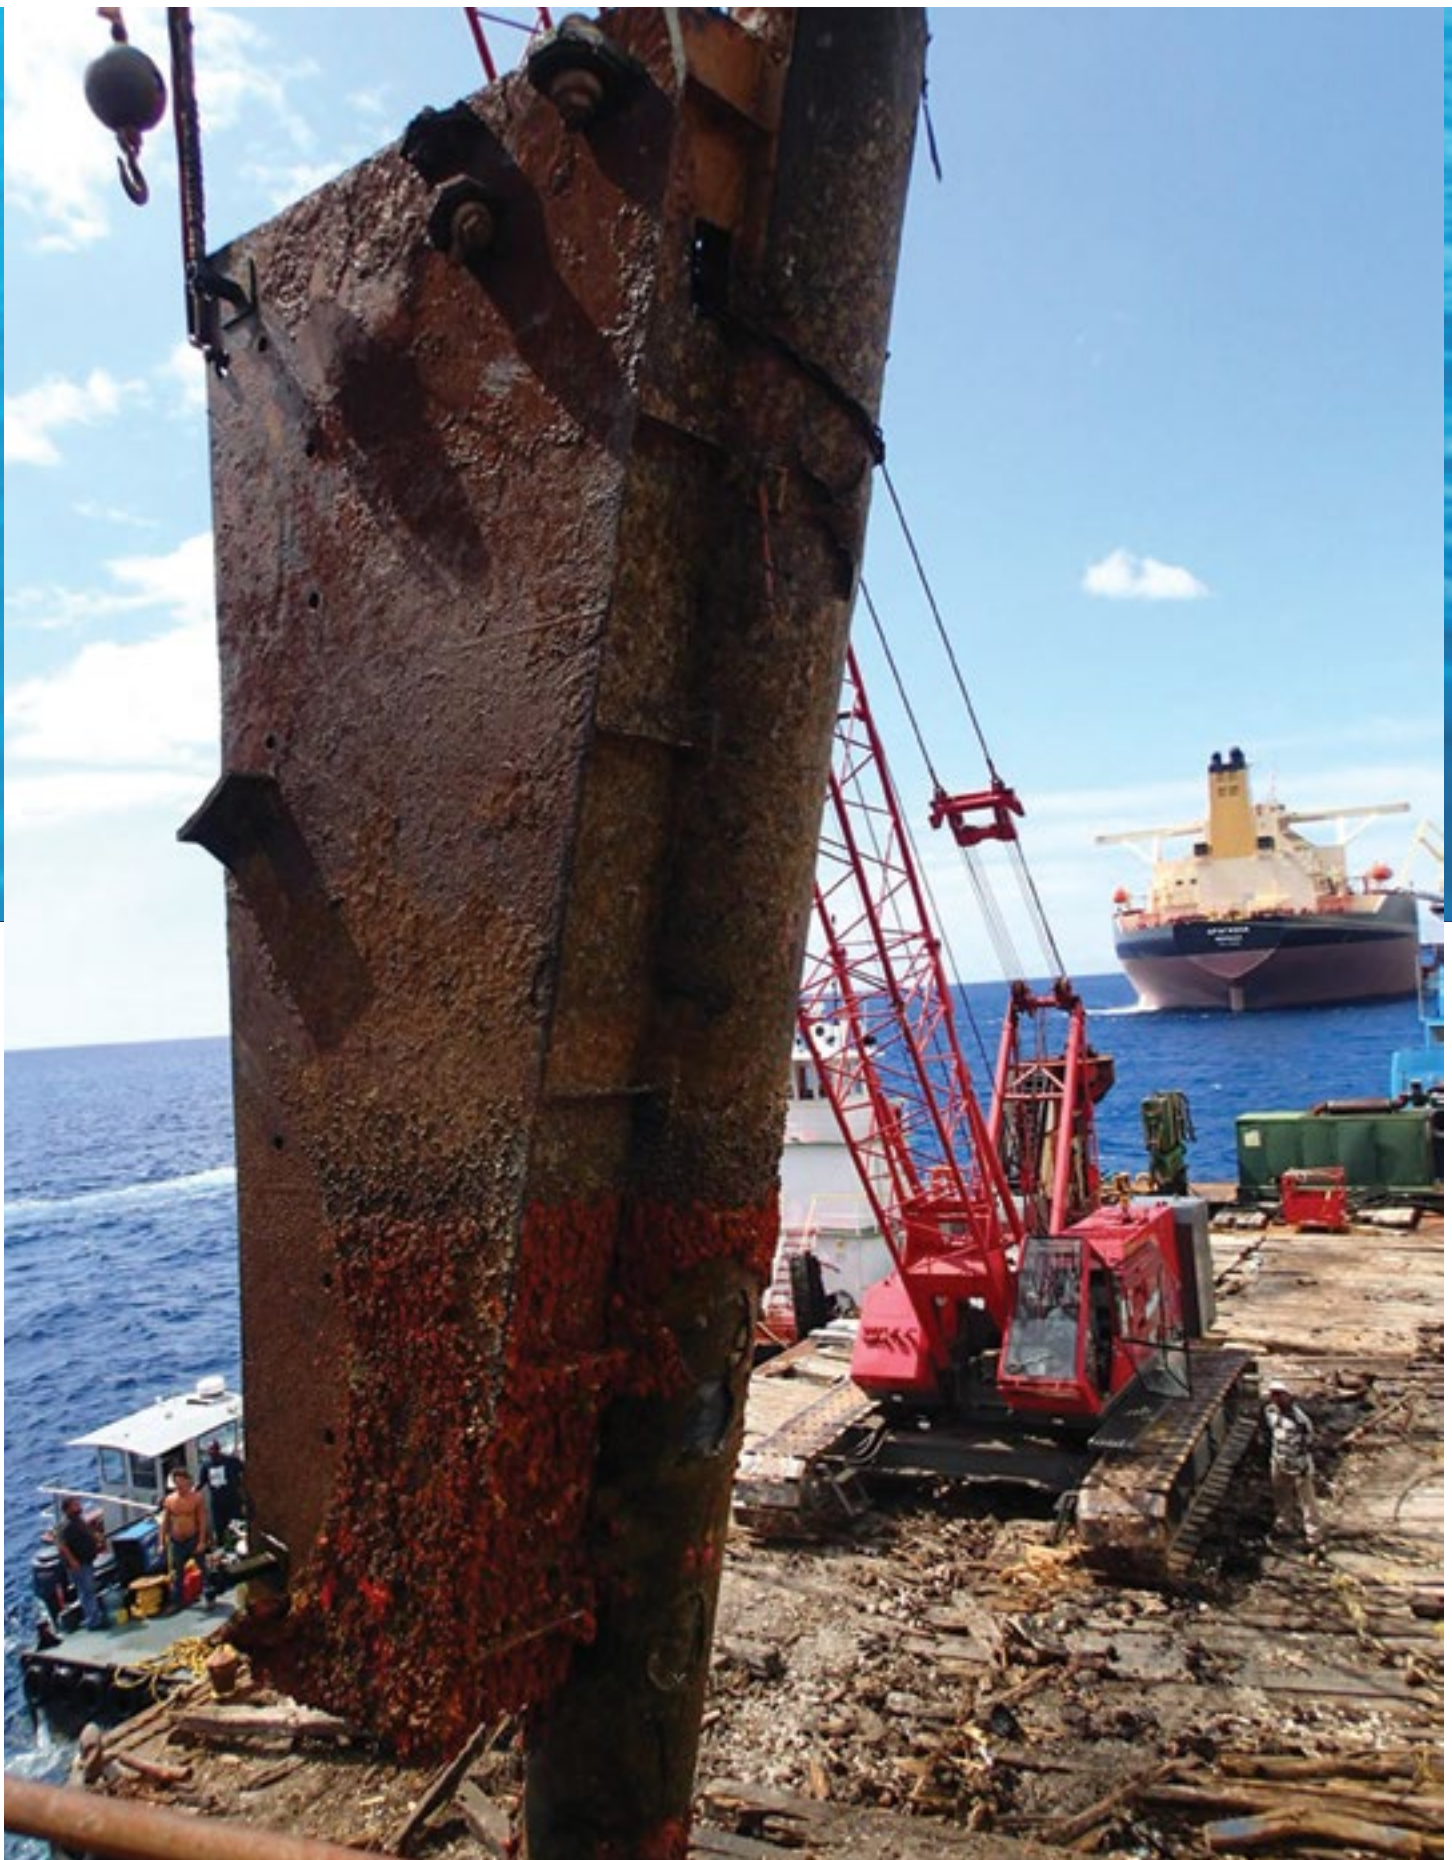
One cut section required two cranes to stabilize it during removal.

section that was positioned directly underneath the existing structure. This section had to be rigged to two cranes to safely remove it from the water without colliding with work barges.
